(NASA-CR-170883) RESULTS OF TESTS ON A
SPECIMEN OF THE SRB AFT SKIRT HEAT SHIELD
CURTAIN IN THE MSFC LRLF (Lockheed Missiles
and Space Co.) 59 p HC A04/MP A01 CSCL 21H

RESULTS OF TESTS ON A SPECIMEN
OF THE SRB AFT SKIRT
HEAT SHIELD CURTAIN
IN THE MSFC LRLF

June 1980

Contract NAS8-32982

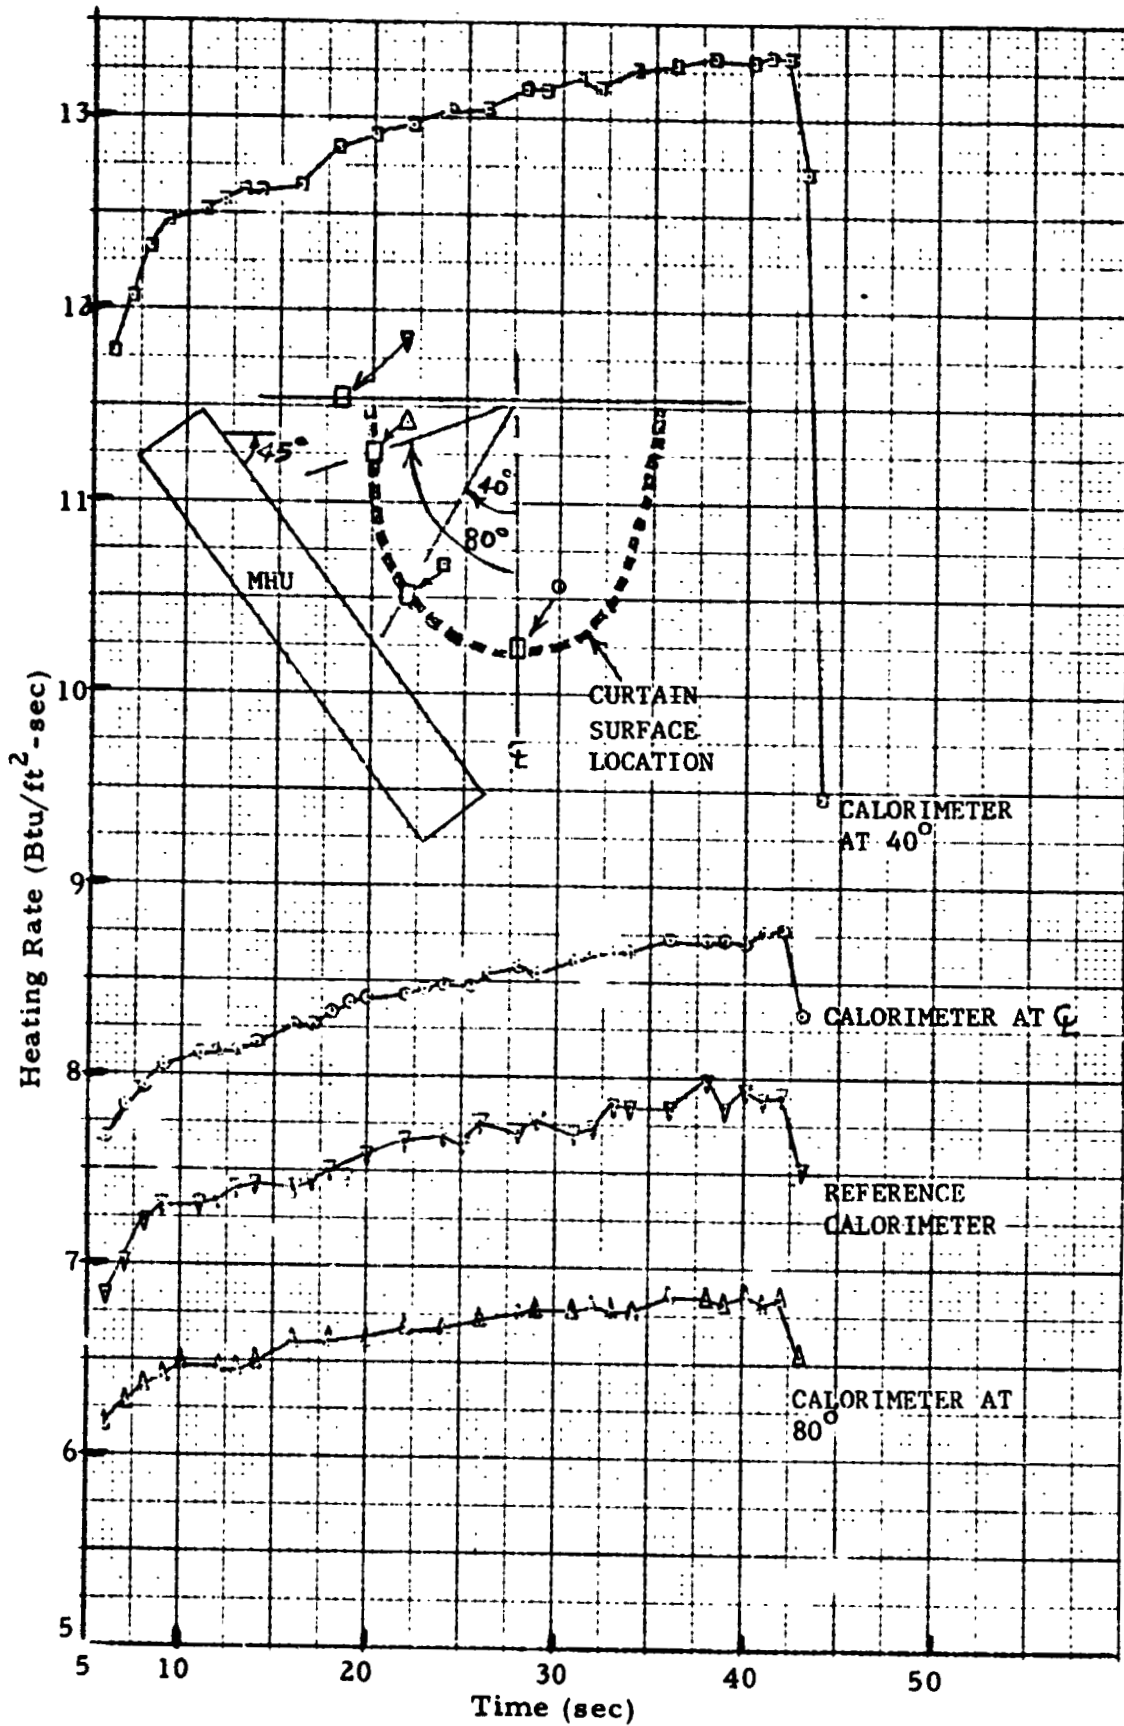
Fig. 12 - Pretest Calibration Run (Heating Rates vs Time)

The first test was a pretest calibration run to determine the \dot{q} levels. This resulted in the \dot{q} values seen in Fig. 12. A conservative value of 12.6 Btu/ft²-sec at 40 deg was selected to arrive at the following time line for the curtain test.

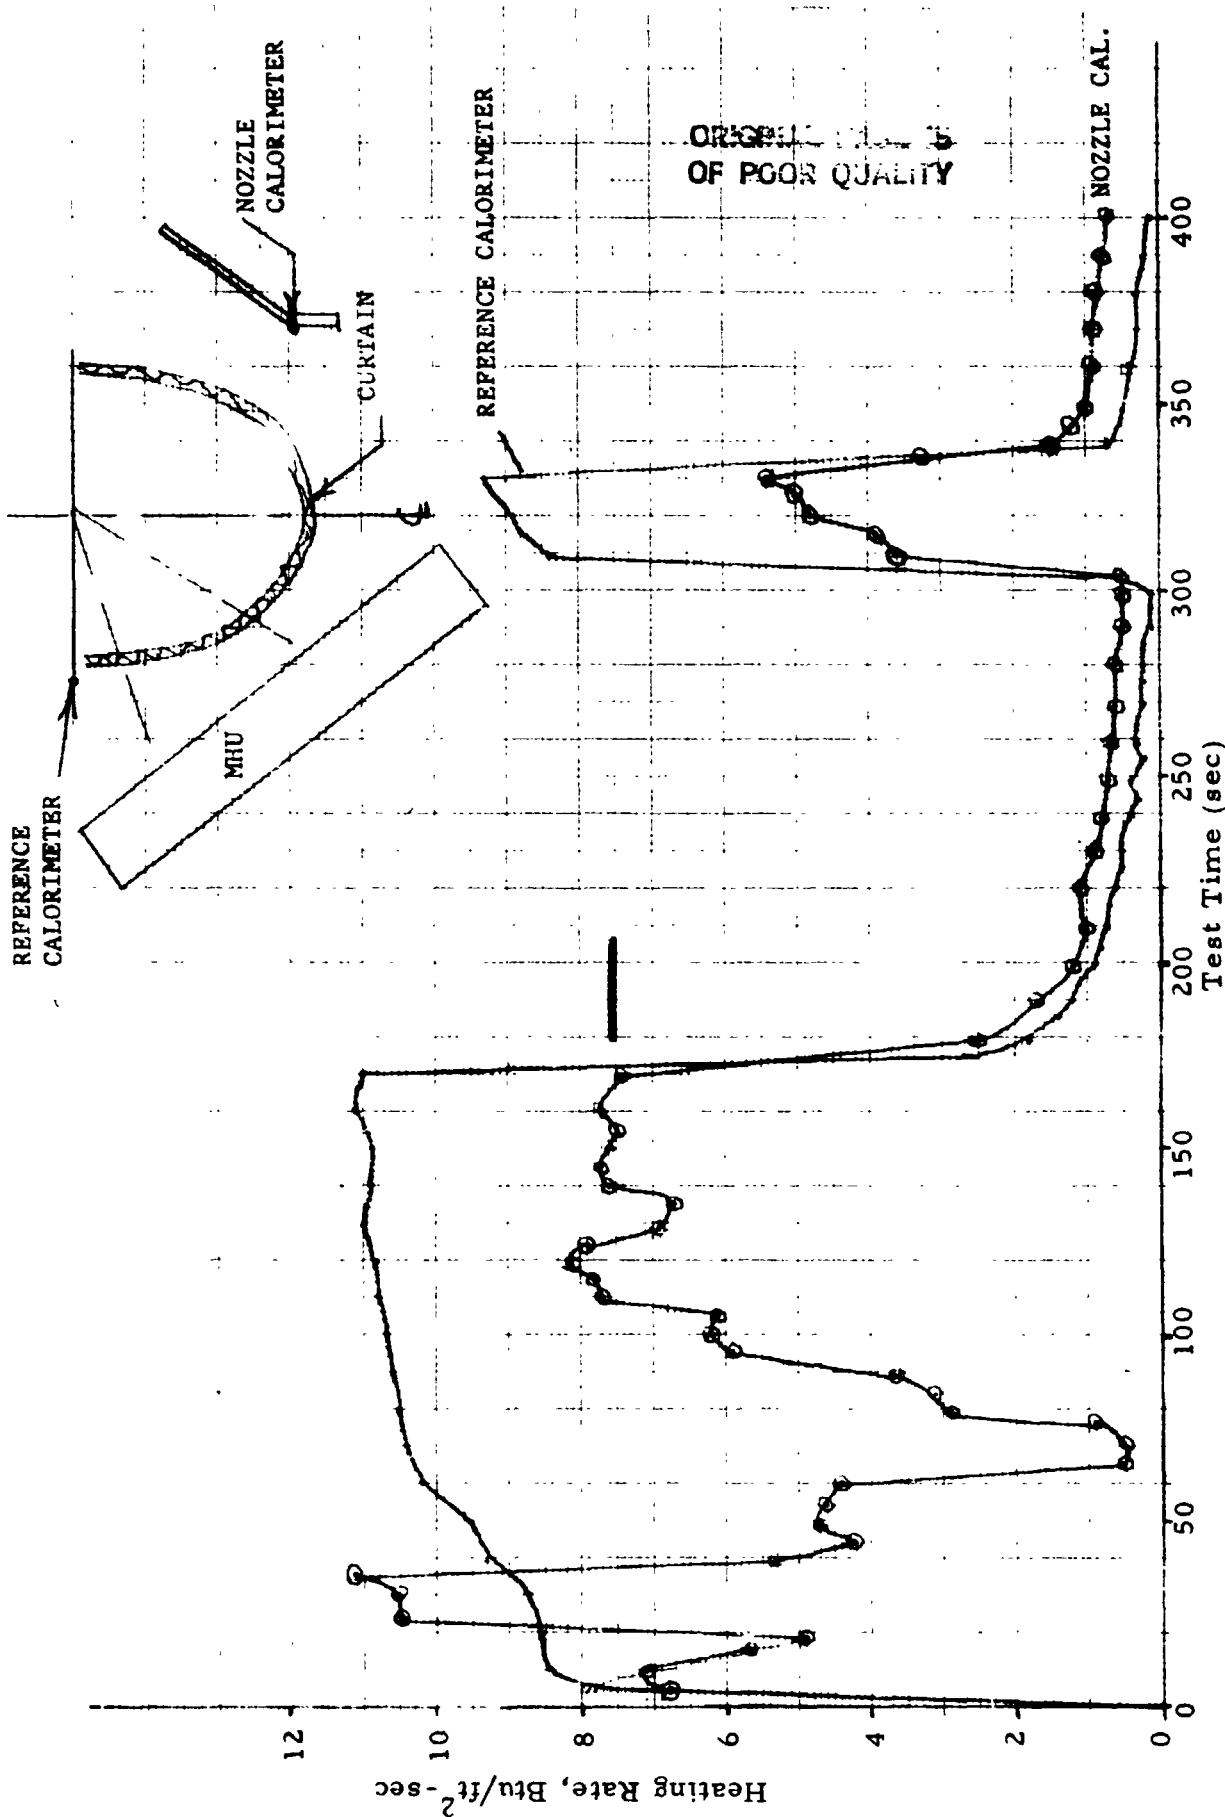
Fig. 25 - Heating Rate vs Time During Curtain Thermal Test for Reference and Nozzle Calorimeters

Post-test analysis of the heating rate data (Fig. 25) showed that the lamps were inadvertently cut off at 172 sec rather than the planned 183 sec. This yielded a reduced heat load margin of 19% rather than the planned 25%. This was declared to be an acceptable margin.

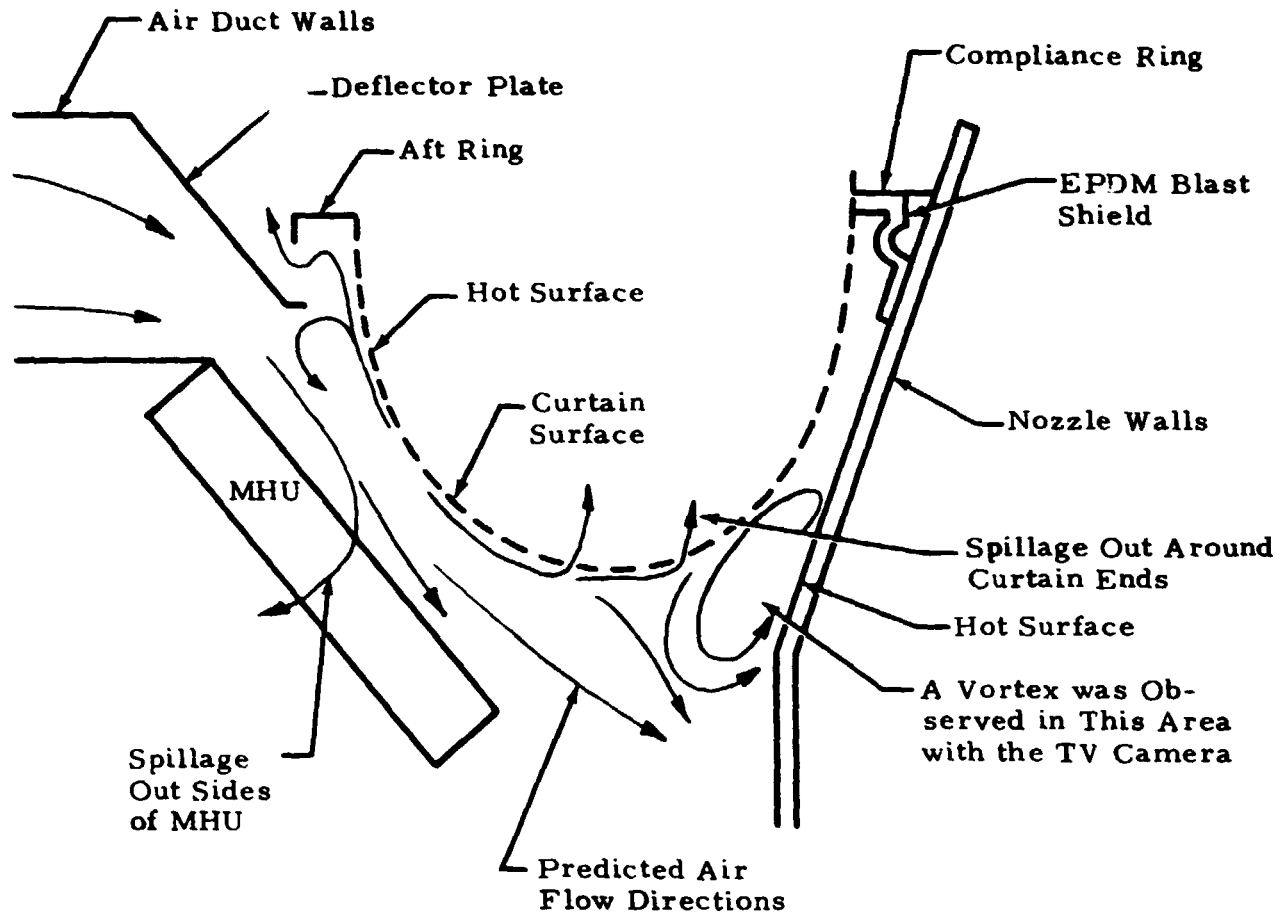
Fig. 40 - Qualitative Prediction of Air Flow Pattern Around Curtain, Nozzle, and MHUs.

Figure 40 shows a qualitative prediction which was made of the air currents to be expected around the curtain and nozzle, taking into account the effects of the convective currents up the heated nozzle wall and burning curtain. A very similar smoke flow pattern was observed by the TV coverage, with a distinct vortex or swirl pattern between the curtain and nozzle.

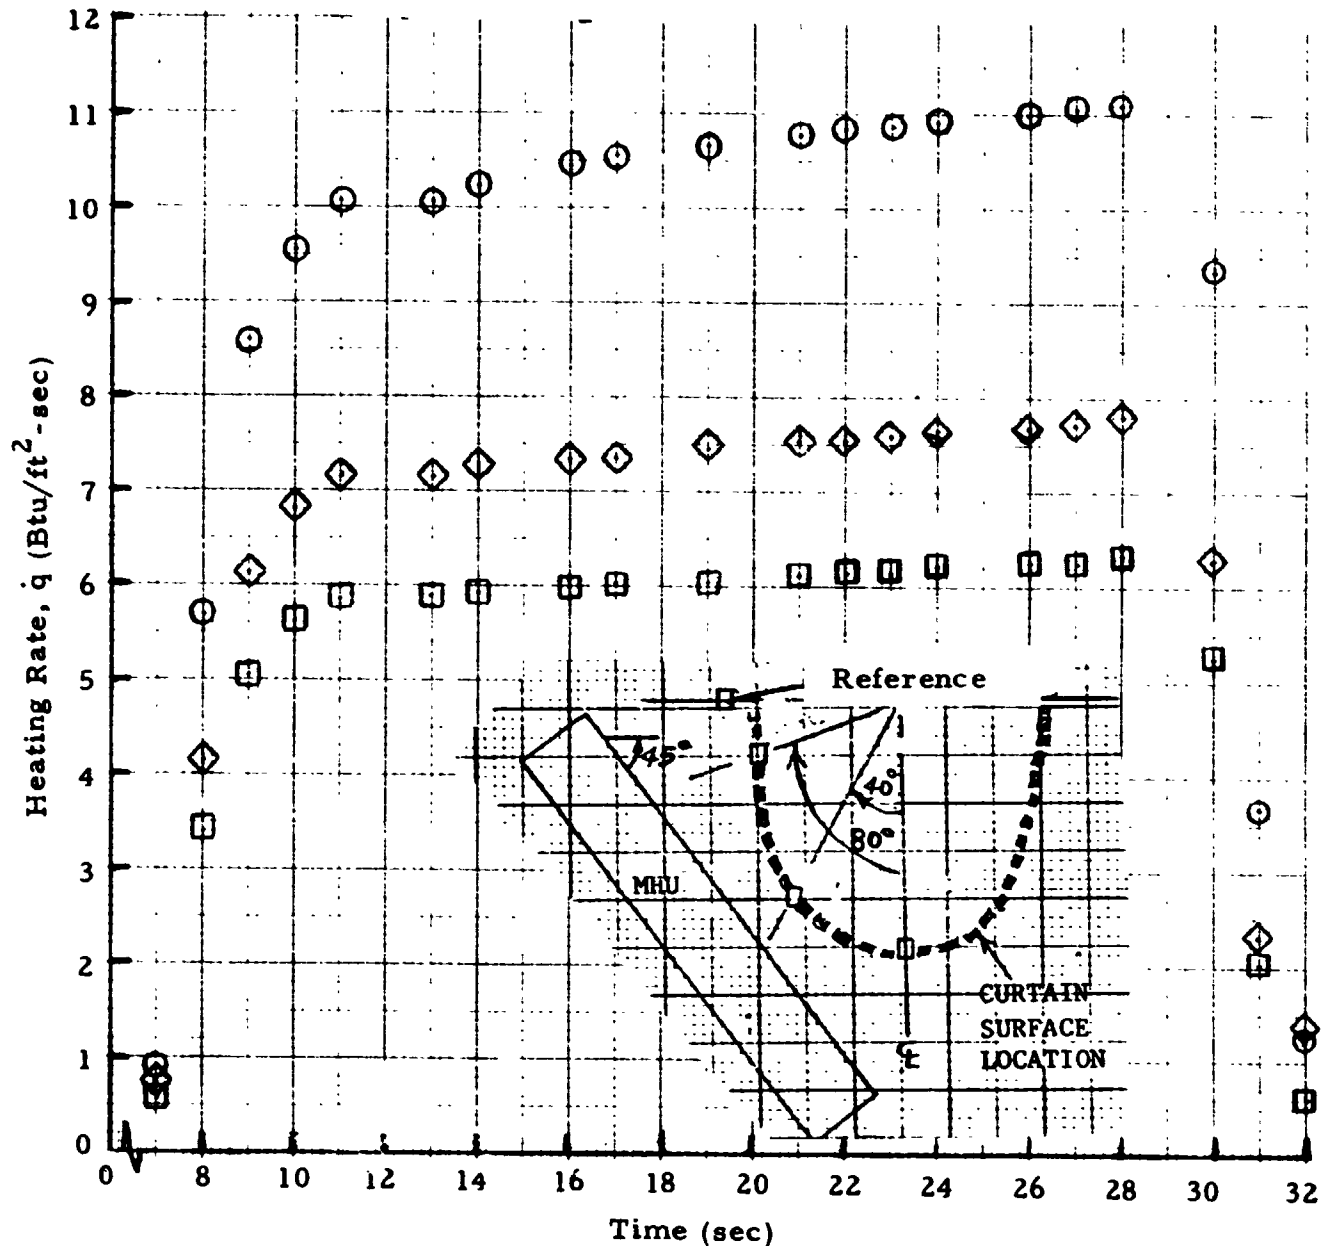
Fig. 41 - Heating Rate vs Time for Post-Test Calibration Run

Post-test calorimeter run data are shown on Fig. 41. The centerline calorimeter was bad and is not plotted. These heating rates are somewhat lower than the pretest values, as would be expected due to lamp contamination, but are still within an acceptable range.

1. ○ $\theta = 40$ deg
2. □ $\theta = 80$ deg
3. ◇ Reference Calorimeter
4. Calorimeter at $\theta = 0$ deg was bad
